## Development of a Portable Electro-mechanical Crack Monitoring Device for Pipeline Steel Materials

**Abstract:** The pipeline infrastructure, particularly in Nigeria face significant challenges arising from defects such as cracks, which could lead to unforeseen leakage of flammable materials, risks to human and aquatic lives and could result in the loss of valuable petroleum products. This paper presents the development of a portable electromechanical device powered by lithium-ion batteries for monitoring surface pipelines for cracks, facilitating timely maintenance to prevent adverse consequences. The device is equipped with two types of electronic sensors mounted on a mobile platform that transmits data to a laptop via microcontrollers (Arduino Nano) and a USB cable. The casing of the device was constructed using polyvinyl chloride modeling board. Three tests were carried out on a 0.75 cm thick test pipe with 21 cm external diameter: No-crack test, initiated crack test, and covered crack test. Operating at 15 cm/s, the device transmitted surface condition data in real-time. The results showed no significant spikes during the no-crack and covered crack tests, while the cracked

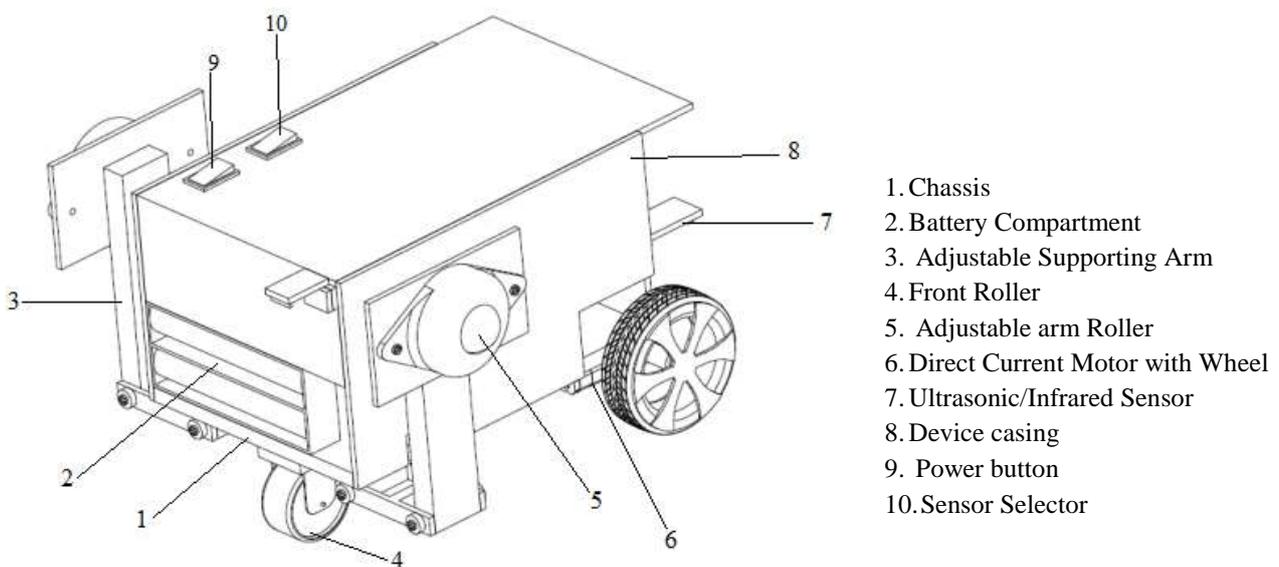
The adopted design of the crack detection device shown in Figure 1 was obtained with the aid of Catia Computer Aided Design (CAD) software.

Figure 1(a): Standard isomeric view of the designed crack detection device

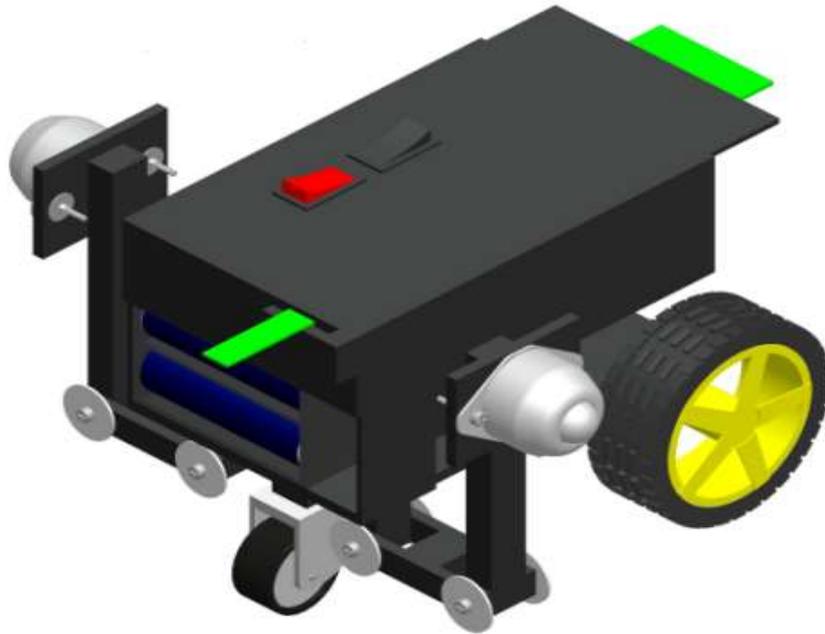
Figure 1(b): Trimetric isometric view of the designed crack detection device

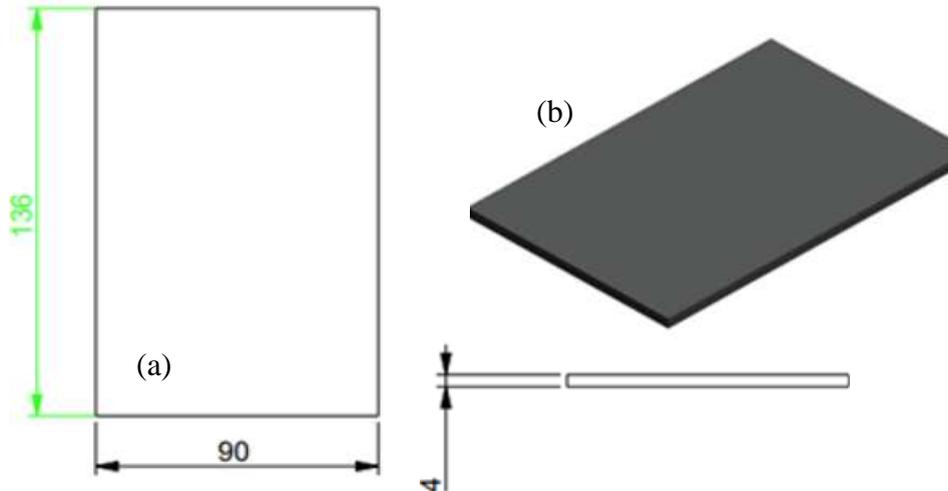
Two identical rectangular pieces of PVC modeling board, each measuring 120 mm x 85 mm x 2 mm, were bonded together using glue, resulting in a rigid board with a thickness of 4 mm, as depicted in Figure 2. Subsequently, two-wheeled DC motors were symmetrically mounted on this chassis along the wheel axis, ensuring stability and balance

Figure 2: The chassis (a) Dimensions (b) Designed part

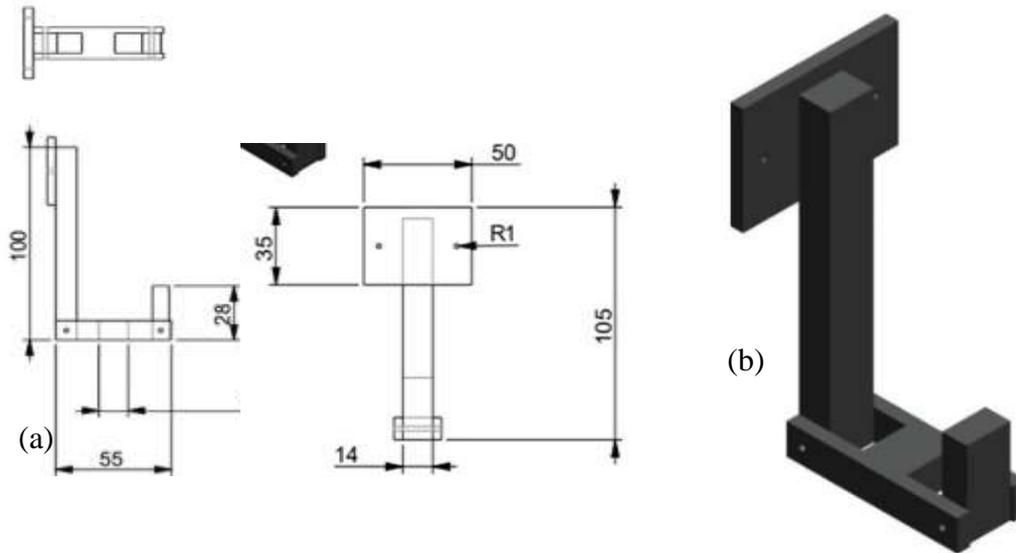
This component, fabricated from PVC modeling board as shown in Figure 3, was attached to both sides of the chassis. The primary function was to prevent the device from slipping off the pipe surface. The component consists of adjustable bolt and nut mechanisms, allowing it to be loosened for positioning and then tightened once optimal contact with the pipe was established.

Figure 3: Adjustable supporting arm (a) Orthographic view (b) Designed part

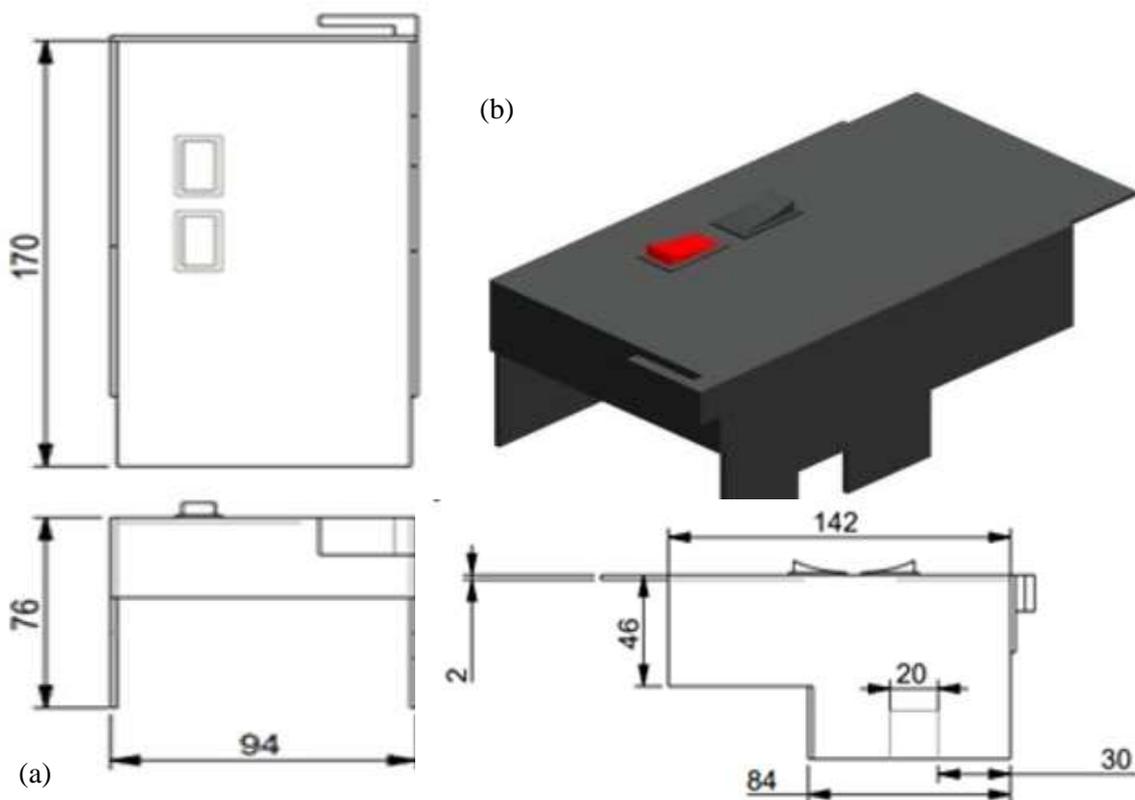
The casing (Figure 4) was constructed using PVC modeling board, known for being lightweight, durable, and easy to work with. PVC sheets were cut, glued, and shaped to form a structure suitable for model making and prototyping. The material's excellent structural properties allowed for drilling and the use of screws, making it ideal for assembling components securely. The casing, presented in Figure 4, was constructed from PVC modeling board, a material known for its light weight, durability, and ease of use. PVC sheets were cut, glued, and shaped to create a structure well-suited for model making and prototyping. The robust structural properties of the material enabled it to withstand drilling and the use of screws, making it an ideal choice for securely assembling components.

Figure 4: The casing (a) Orthographic view (b) Designed part

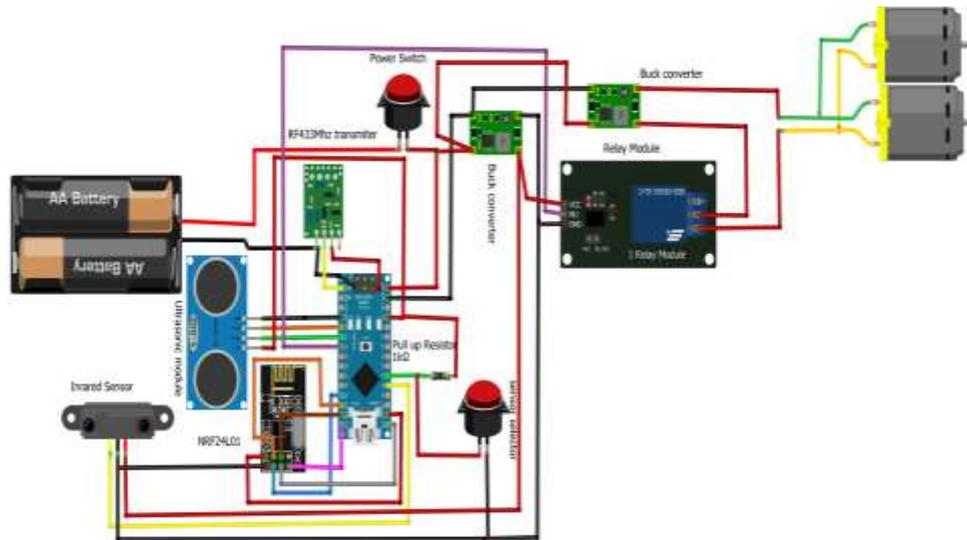
The control system consists of two units: the transmitter unit, which acts as the inspection device, and the receiver unit, functioning as the controller. The transmitter unit is powered by two 3.7V lithium-ion batteries and incorporates an ultrasonic sensor, an infrared sensor, a microcontroller (Arduino Nano), a relay, a buck converter module (motor driver), and an electric motor for device movement. As illustrated in Figure 5, the Arduino Nano interfaces with both sensors and connects to the motor driver board, comprising the relay and buck converter, enabling it to send signals to regulate motor speed. While collecting data, the ultrasonic and infrared sensors relay information to the microcontroller, which then transmits it wirelessly via the radio module.

Figure 5: Circuit diagram of the developed transmitter unit

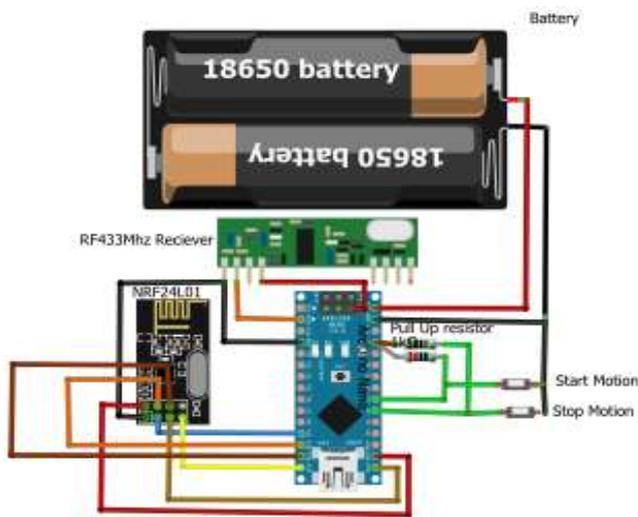
Also, the receiver unit functions as the motion controller for the device and is powered by two 3.7V lithium-ion batteries. It includes a microcontroller and a radio frequency (RF) receiver. As shown in the circuit diagram presented in Figure 6, the RF receiver is connected to the Arduino, which receives the signal and interprets it. The interpreted data was then transmitted to a computer system via the USB port

Figure 6: Circuit diagram of the receiver unit

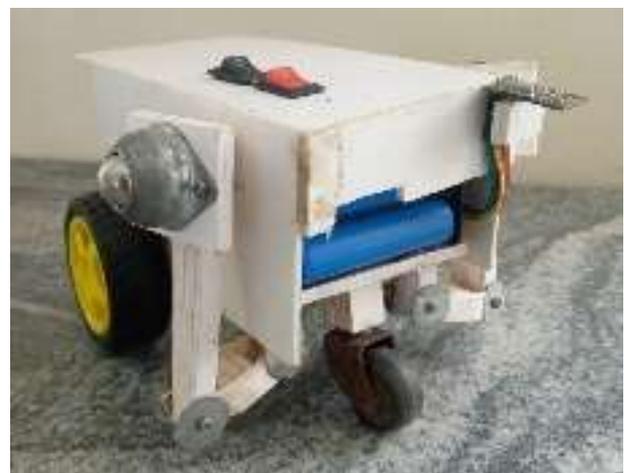
The assembled monitoring device, presented in Figure 7, comprises of a control system and a mobile crack detection unit. A pair of lithium-ion batteries, collectively providing 14.8V to ensure continuous operation, powers both components. The device's structural components, including the casing of the control system, the chassis of the mobile unit, the adjustable supporting arm, and the main enclosure, are all fabricated from 2 mm thick polyvinyl chloride (PVC) modeling board.

Figure 7: Assembled device

- ii. The developed device has a weight of 0.6kg and overall dimensions of 230mm x 218mm x 137mm, making it portable and easy to transport to deployment sites. It can move along the outer surface of the test pipeline without slipping.

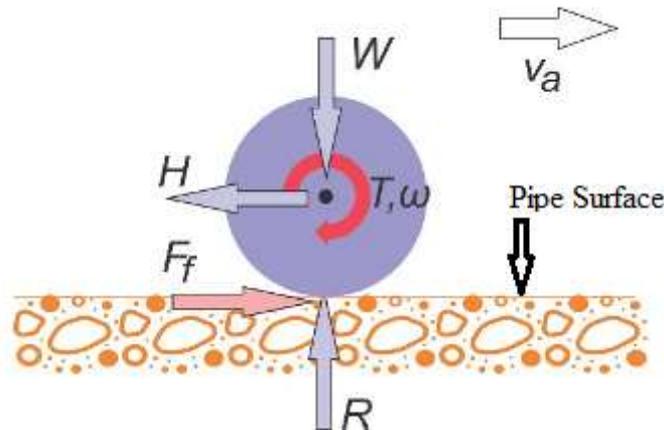
The traction devices consist of two rear wheels directly connected to the motors, while the front wheel and the wheels on the adjustable arm serve as transport devices. In the analysis, some assumptions were made: the rear wheels were simplified to a single wheel, the wheel was assumed to move at constant velocity, and the total weight of the device was considered to act on the wheel axle. This setup is shown in Figure 8, showing the forces acting at the point where the wheel contacts the pipe surface.

The parameters shown in the figure are described as presented in Equation (1-13), where  $\omega$  = Angular velocity of the wheel (rad/s),  $H$  = Net tractive force (N),  $T$  = Torque transferred to the wheel axle (Nm),  $V_a$  = Actual velocity of the wheel (m/s),  $R$  = Vertical reaction force (N),  $F_f$  = Frictional force (N) and  $W$  = Dynamic wheel load (N).

Figure 8: Wheel tractive force variables [20]

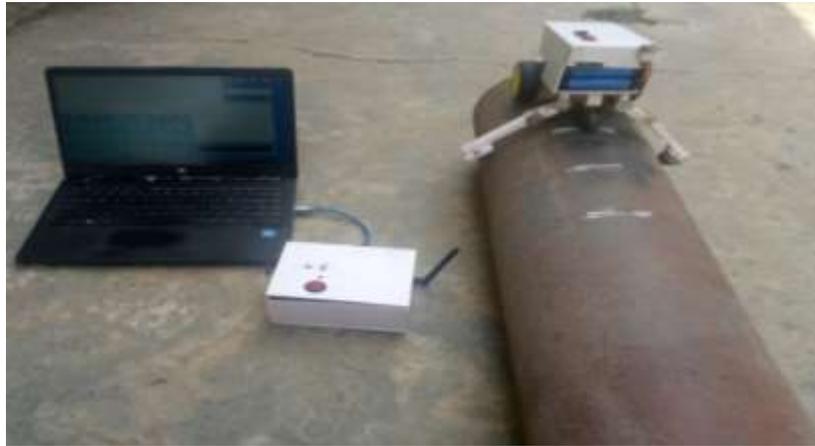
The experimental setup of the developed device, as shown in Figure 9, involved positioning the inspection device on the pipe with its sensor aligned to the 0 cm start-up mark. Both the inspection device and controller unit were powered on, and the Arduino IDE software was launched on a laptop, set to the plotter option. The inspection device remained stationary until a move command was issued from the controller unit, enabling it to traverse the pipe's external surface. During testing, the plotter recorded data on the distance between the sensor and the pipe surface at the 0 cm mark over time. Subsequently, infrared and ultrasonic sensors were interchanged using their respective attachments. Upon receiving a move command, the microcontroller transmitted a signal from the transmitter to the receiver in the inspection unit, which processed it and directed the motors via the motor driver to initiate movement. A stop command could be issued at any time to prevent the device from falling off the pipe.

As the inspection device traversed the pipe, it plotted the sensor-to-surface distance against time on the Arduino IDE platform, with spikes on the plot indicating detected cracks. Operating at a speed of 15 cm/s, the device underwent three tests: first, on a crack-free pipeline to establish baseline no-defect characteristics; second, on a pipeline with three artificial cracks (each 0.5 cm deep and 1 cm wide) positioned at 20 cm, 30 cm, and 40 cm marks to simulate real defects; and finally, on cracks covered with masking tape to evaluate its effectiveness in detecting concealed cracks.

Figure 9: Experimental setup

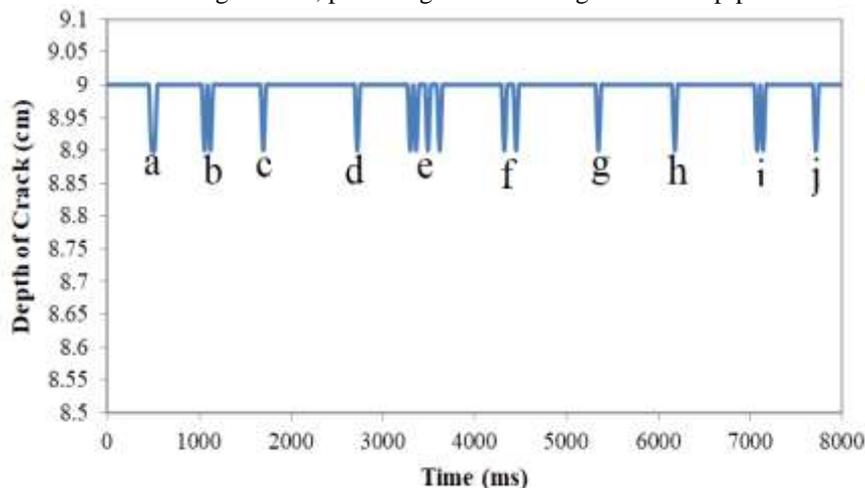
The results of the no-crack test using the ultrasonic sensor and infrared (IR) sensor are shown in Figures 10 and 11, respectively. Both figures display several downward spikes, labelled as a, b, c,..., j in Figure 10 and a, b, c,..., f in Figure 11. These spikes represent a reduction in the distance between the sensors and the pipe's external surface, indicating surface irregularities or roughness at specific locations. The spikes occurred as the sensors detected bumps or imperfections on the pipe's surface, registering closer proximity [26]. This behaviour underscores the sensitivity of both ultrasonic and infrared sensors to variations in surface texture, allowing them to identify not only cracks but also other anomalies that could compromise pipeline integrity. These findings highlight the effectiveness of the inspection device in detecting structural flaws and surface irregularities, providing valuable insights into the pipe's condition.

Figure 10: No-crack plot for ultrasonic sensor

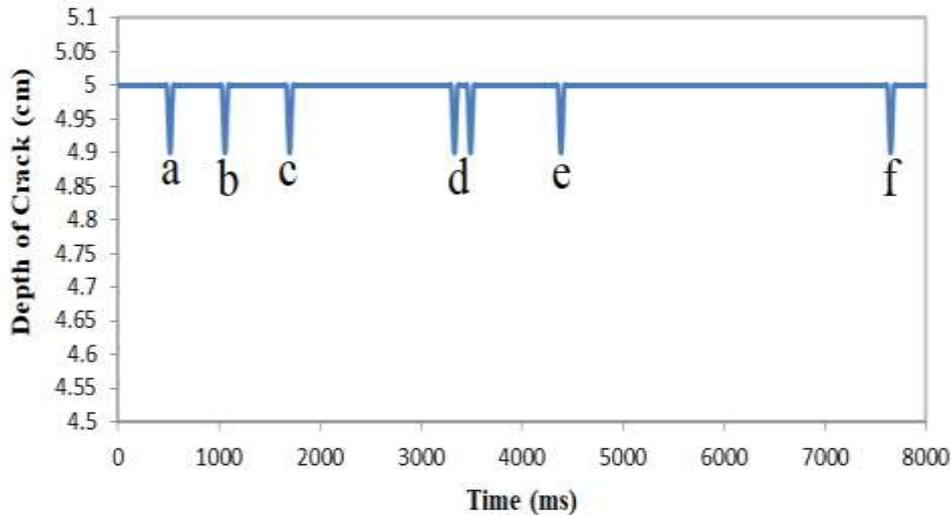
Figure 11: No-crack plot for infrared sensor

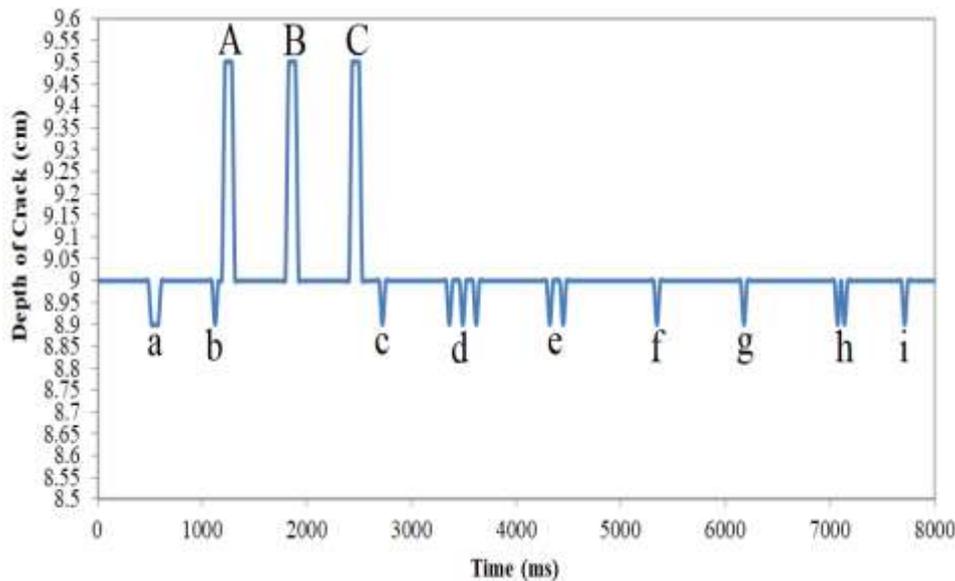
The results of crack detectability tests using ultrasonic and infrared (IR) sensors are presented in Figures 12 and 13, respectively. Similar spikes observed in Figures 10 and 11 are also evident in Figures 12 and 13, labeled as a, b, c,..., i and a, b, c,..., f, a, b, c,..., g. These spikes represent bumps on the pipe surface with a thickness of approximately 0.1 cm at the indicated points. Additionally, distinct sharp spikes labeled A, B, and C corresponds to the positions of the initiated cracks on the pipe surface. The height of these spikes reflects the depth of the cracks, measured at 0.5 cm. Both ultrasonic and IR sensors effectively detected cracks on the pipe surface; however, the ultrasonic sensor demonstrated superior performance in identifying bumps and rough points compared to the IR sensor. This difference may arise from the roughness of the pipe surface, which reduces the amplitude of readings from the IR sensor but has minimal impact on ultrasonic sensor readings. The graphs (Figures 10 to 14) under various testing conditions highlight this distinction, emphasizing the ultrasonic sensor's robustness in detecting both surface irregularities and structural flaws.

Figure 12: Cracked pipe plot for ultrasonic sensor

From the result in Figure 12, the times corresponding to the location of the three initiated cracks are  $t_1 = 1300$  ms,  $t_2 = 1900$  ms, and  $t_3 = 2500$  ms.

The locations of the three initiated cracks were determined to be approximately 20 cm, 29 cm and 38 cm respectively.

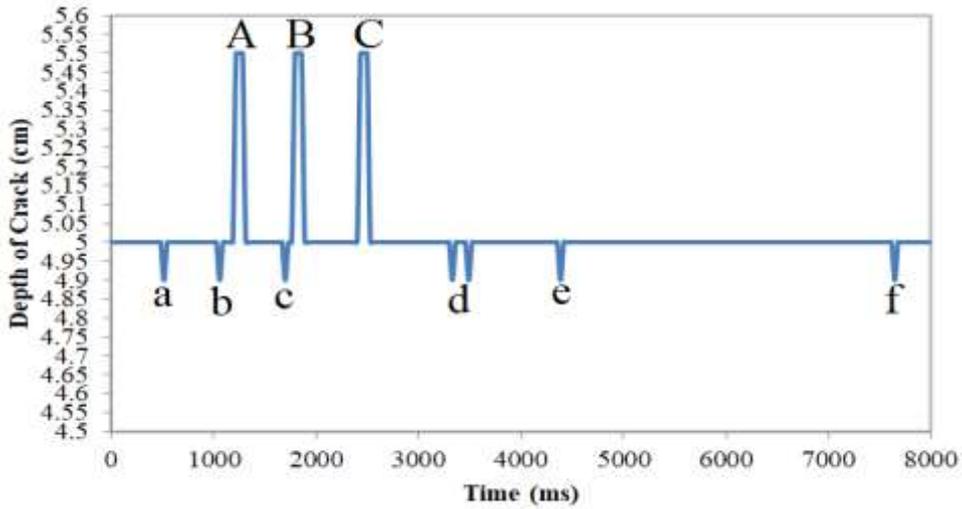
Figure 13: Cracked pipe plot for infrared sensor

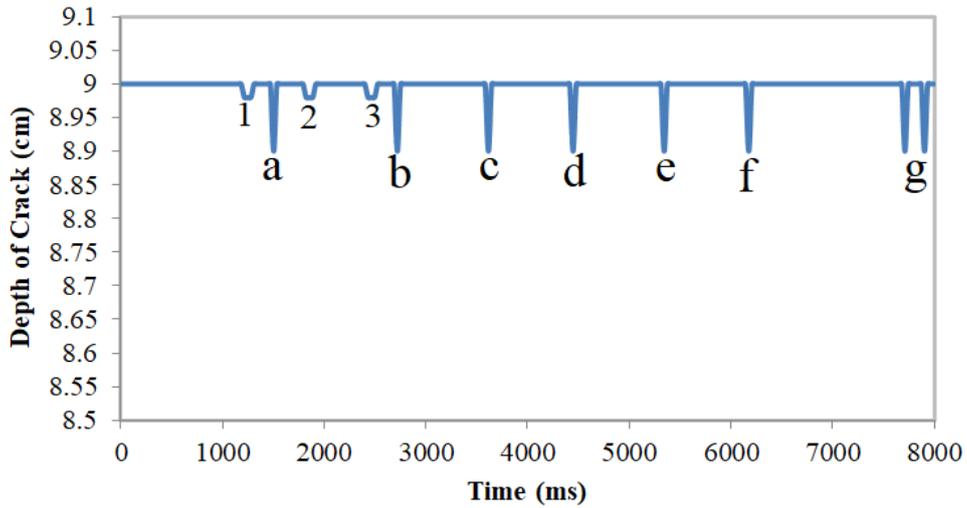
The experimental results of testing cracks covered with masking tape, simulating the presence of foreign material on the pipe surface, are shown in Figures 14 and 15 for ultrasonic and infrared sensors, respectively. Similar to Figures 10 and 11, these figures display spikes labeled as a, b, c,..., g and a, b, c,..., f, representing bumps on the pipe surface with a thickness of approximately 0.1 cm at the indicated points. However, unlike uncovered cracks, Figures 14 and 15 exhibit mild downward spikes labeled 1, 2, and 3 at the locations of the cracks. These mild spikes suggest that the sensors as surface roughness rather than distinct cracks interpreted the masking tape covering the cracks. The masking tape's thickness was measured at approximately 0.025 cm based on the results. While the masking tape did not produce

pronounced signals like uncovered cracks, it caused slight variations in the sensor readings, demonstrating its influence on crack detection performance [27].

Figure 14: Covered crack plot for ultrasonic sensor

- iv. The device effectively detected cracks in pipelines; however, when the cracks were covered, the sensors did not register any spikes. Instead, they measured the thickness of the tape, which was found to be 0.025 cm.

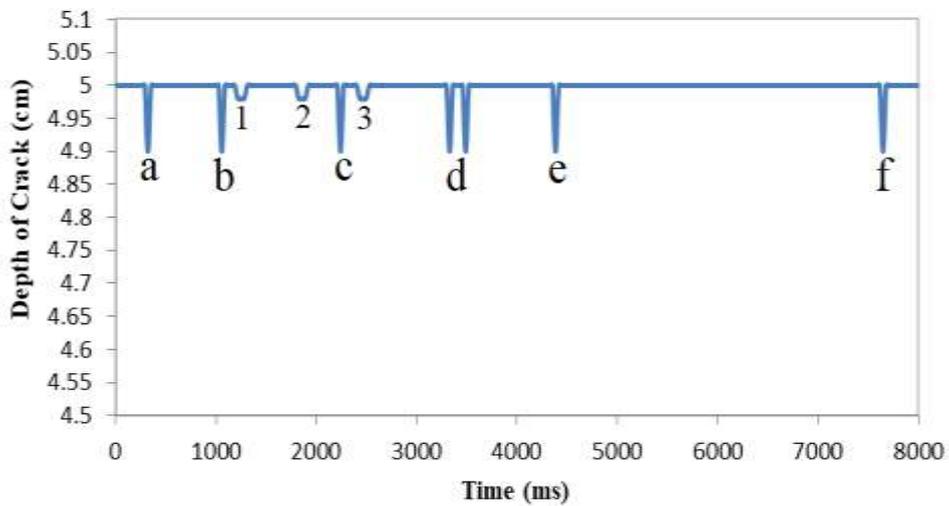
Figure 15: Covered crack plot for infrared sensor
